## Enhancing the resilience of community-led energy systems and mid-hill landscapes in Nepal: Two cases of multi-layered bioengineering

This comparative case study examines the application of bioengineering practices across two distinct micro-hydropower sites in Nepal: the Girikhola Jalapadevi MHP in Jumla District and the Nisikhola III MHP in Baglung District.

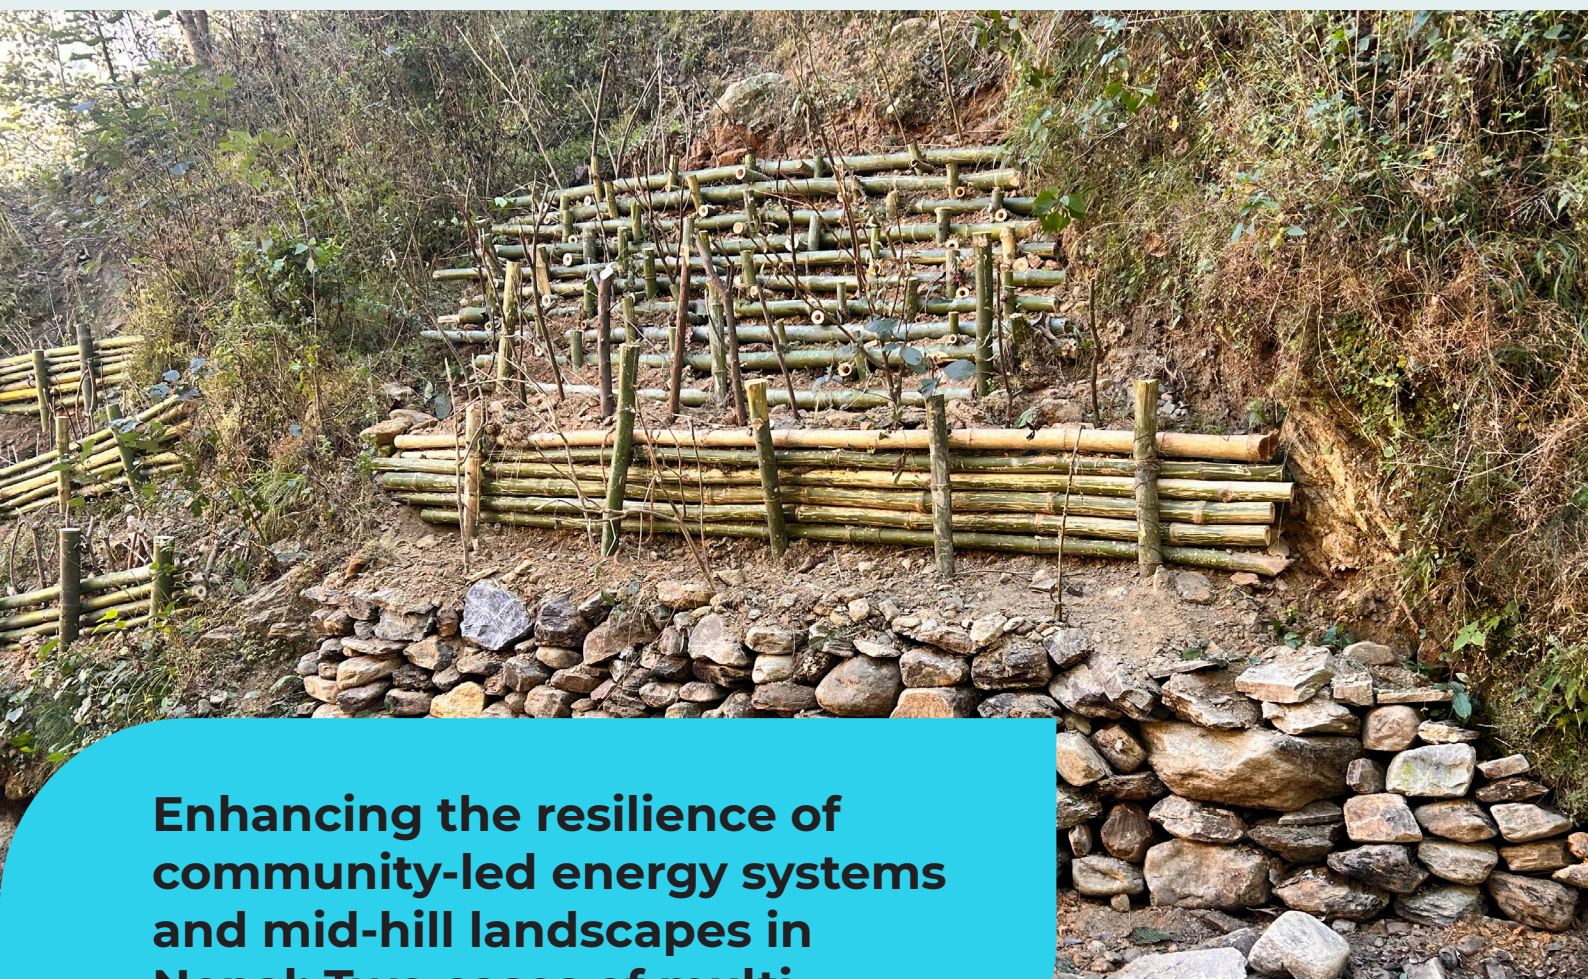
Dry stone walls and bamboo retaining walls on the bank of a stream flowing into the Nisi River in the Baglung district.  
Photo by RECOFTC

- **Dry Stone Walls:** Four mortar-free dry stone walls were placed at ground level below the retaining walls along continuous water flow lines to protect slope toes from river erosion.

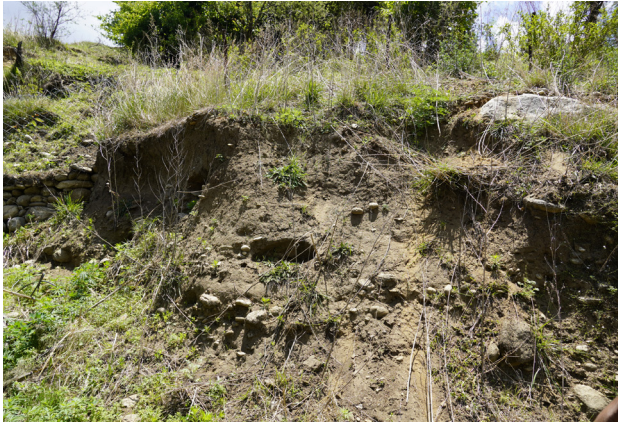
Slope before Installation of Crib Wall

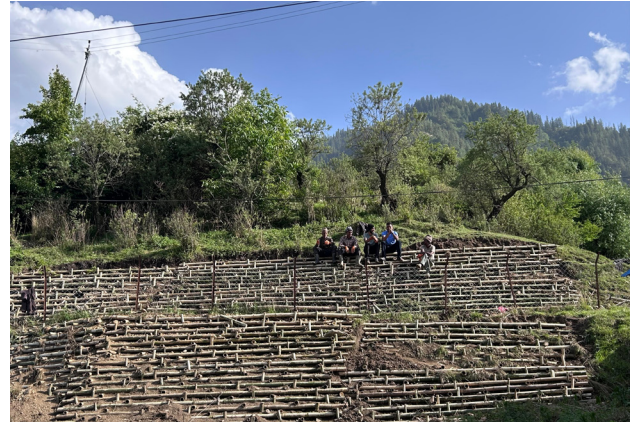
After Installation of Crib Wall

- **Bamboo Crib Walls:** Six crib walls (totaling ~70 m<sup>3</sup>) were constructed in crisscross patterns along unstable slopes upslope of the retaining walls to intercept surface runoff and stabilize soil.

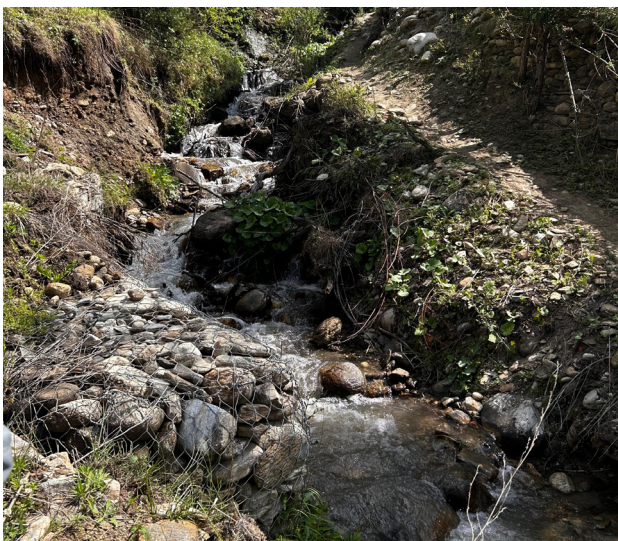
Condition of river beside operator house before gabion installation.

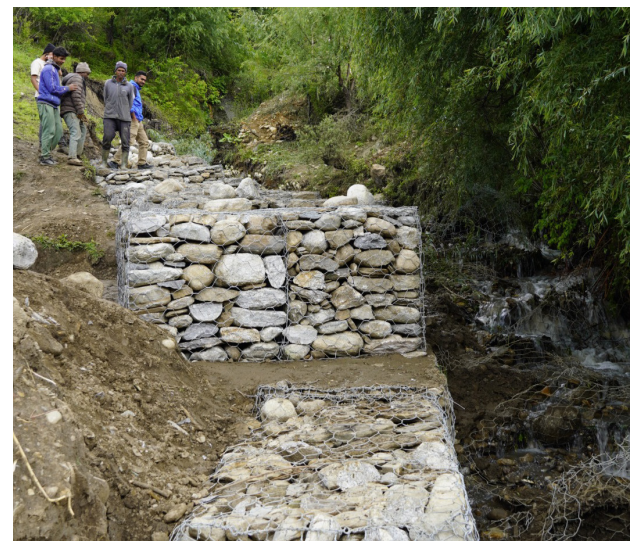
Condition after installation of gabion walls

- **Gabion Walls:** A total of 35 gabion walls filled with local river cobbles were installed - 7 directly behind the powerhouse and 28 along the riverbank by the operator's house - to deflect flood energy and prevent scouring.

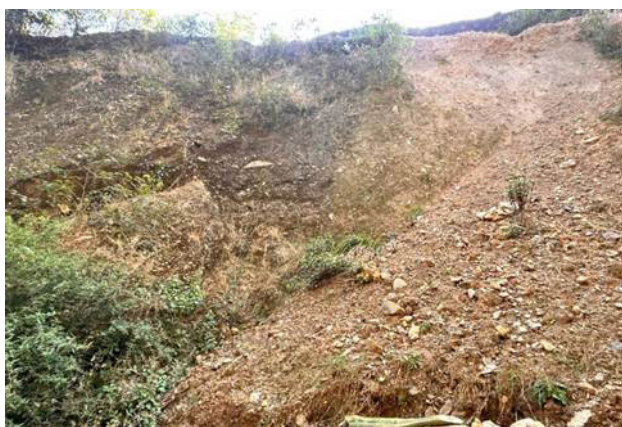
Slope adjacent to the road above the powerhouse and the channels before intervention

The newly constructed road above these infrastructures and rivers caused massive landslides, directly affecting upstream areas of the forebay and powerhouse. This landslide, when mixed with flood in seasonal rivers, increases the risk of inundation in the powerhouse.

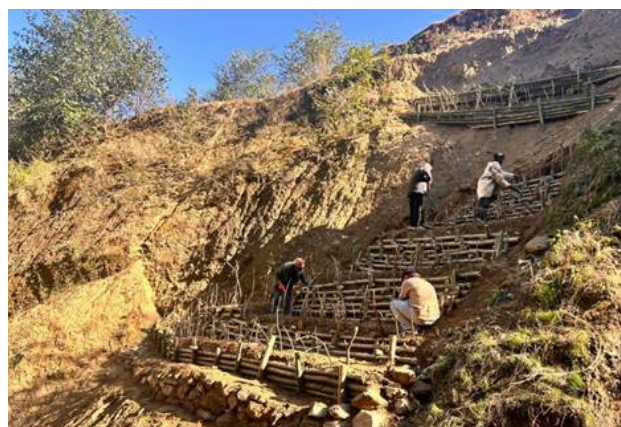
After intervention: Dry stone walls, Bamboo Retaining wall and Bamboo Crib walls are constructed

- **Bamboo Crib Walls:** Nine crib walls were installed along erodible slopes to provide immediate structural support and trap soil movement, with vegetative branches inserted between bamboo layers.

- **Bamboo Retaining Walls:** Twelve retaining walls constructed from bamboo and binding wire were placed below crib walls to support minor ground movement.

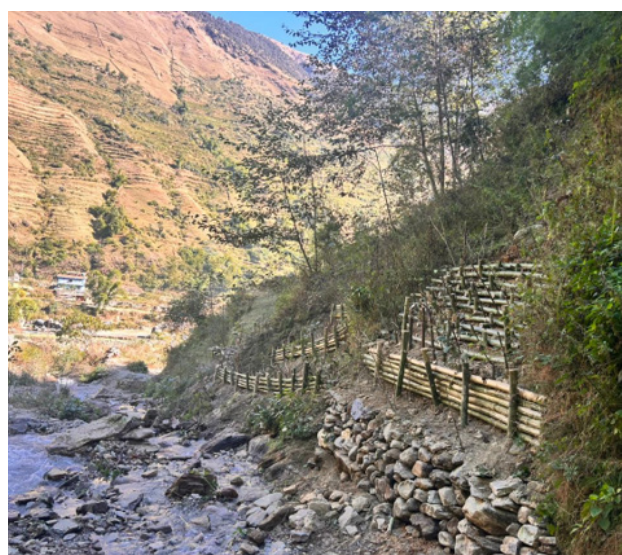
Bioengineering on the riverside of one of the streams flowing beside the powerhouse

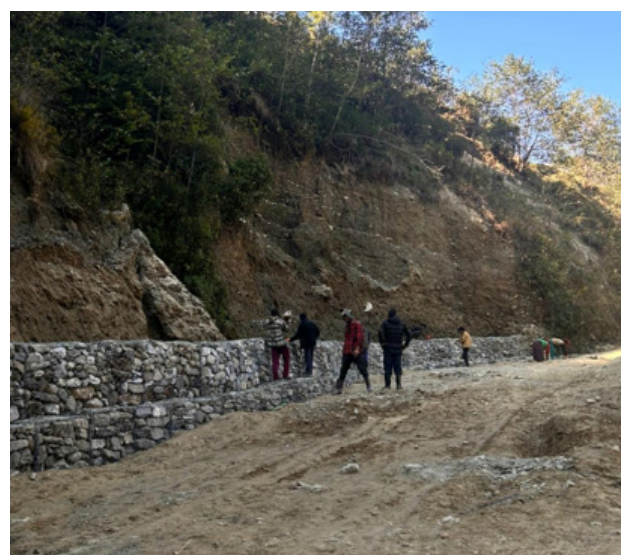
Gabion walls installed for landslide protection above the powerhouse

- **Gabion Walls:** Approximately 120 m<sup>3</sup> of gabion walls were installed across two high-vulnerability sites where vegetation alone could not offer sufficient structural resistance.

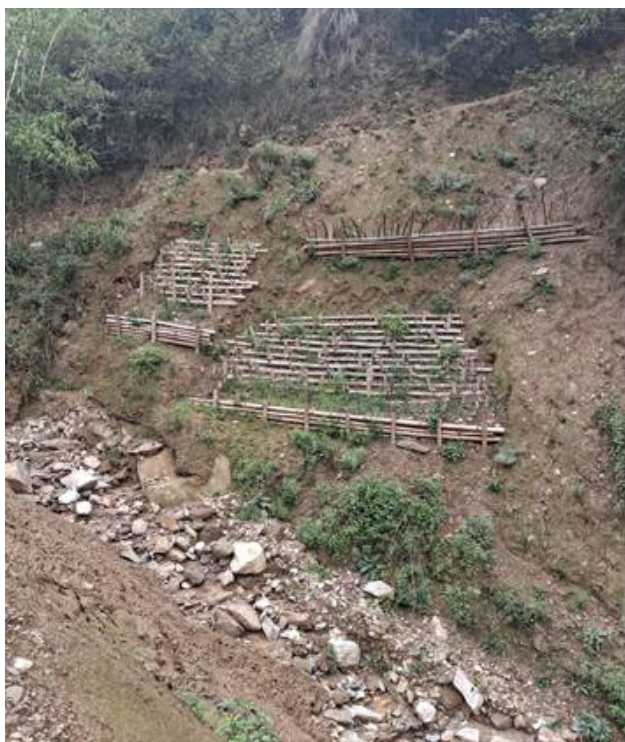
Some of the structures in Baglung case by June 2026. a) Bamboo crib walls are still stable but with a low rate of vegetative establishment. b) intact gabion walls.

After the follow-up with the focal persons, as of June 2026, most of the structures in both sites are still in place, however, very few plants have grown successfully and many dried up. Some of the retaining walls that were constructed above the crib walls have fallen, however, other crib walls and dry stone walls are intact. Thus significant part of the basic structures are still stable (e.g. bamboo crib walls and dry stone walls) this allows for replantation of the vegetable elements. Moreover, technical knowledge for reinforcing or even complementing the destabilized structures is available at the provincial SWMO. However, difficulties to mobilize the needed resources (i.e. technical support, vegetative branches and labour) persists.
